4 Point Inspection Report

Jeffrey Bolocs
3452 SE Fairway East
Stuart, FL 34997
January 01, 2020

4-Point Inspection Form

INSURED/APPLICANT NAME Jeffrey B[] & APPLICATION / POLICY # _____
 ADDRESS INSPECTED: HIGUE Fairway OceanStuart, FL 34997
 ACTUAL YEAR BUILT: 1977 DATE INSPECTED: January 6, 2020

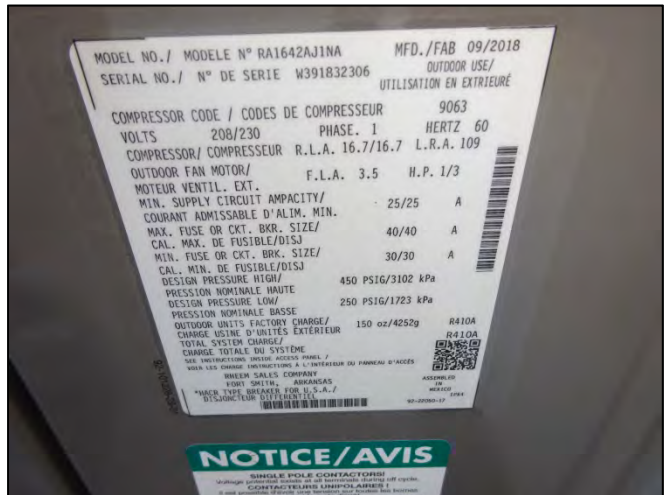
HVAC Label MFD: 09/2018

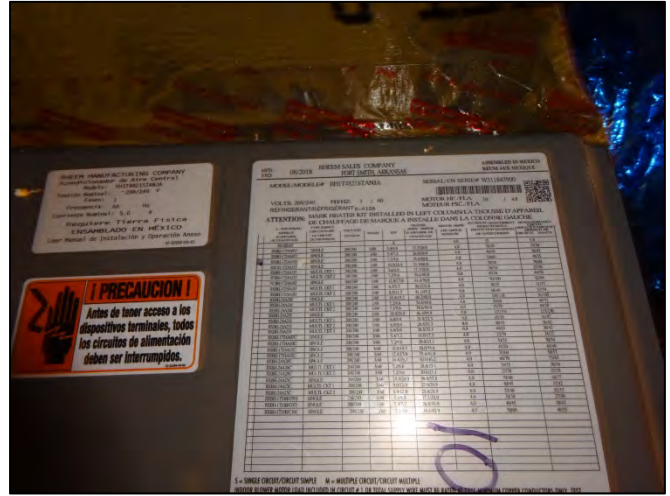
HVAC Label MFD: 08/2018

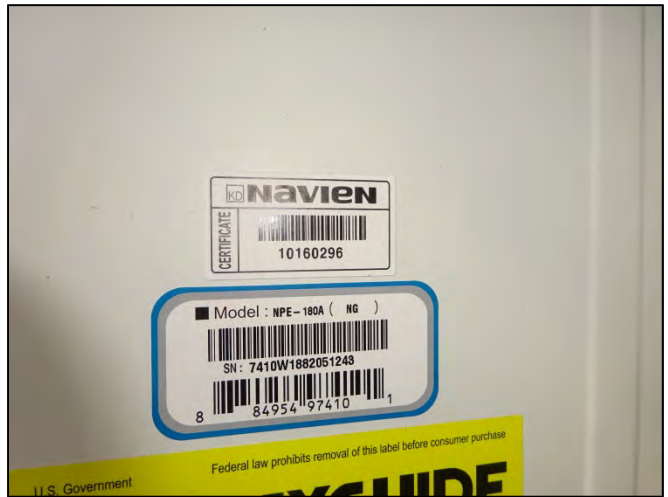
Water Heater Label MFD: 10/2018

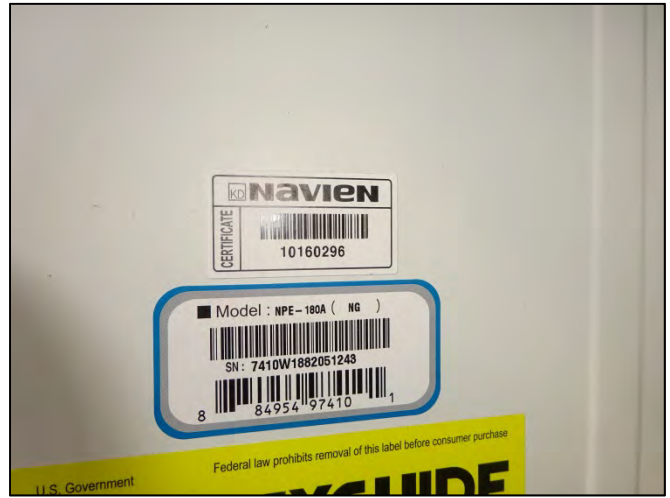
Water Heater Label MFD: 10/2018
